REBUTTAL EXPERT REPORT OF STEVE W. MARTIN, Ph.D.

*Marcellin and Estate of Hollowell v. HP Inc., and Staples, Inc.*

**I. EXTERNAL FIRE CAUSING THERMAL RUNAWAY REACTION**

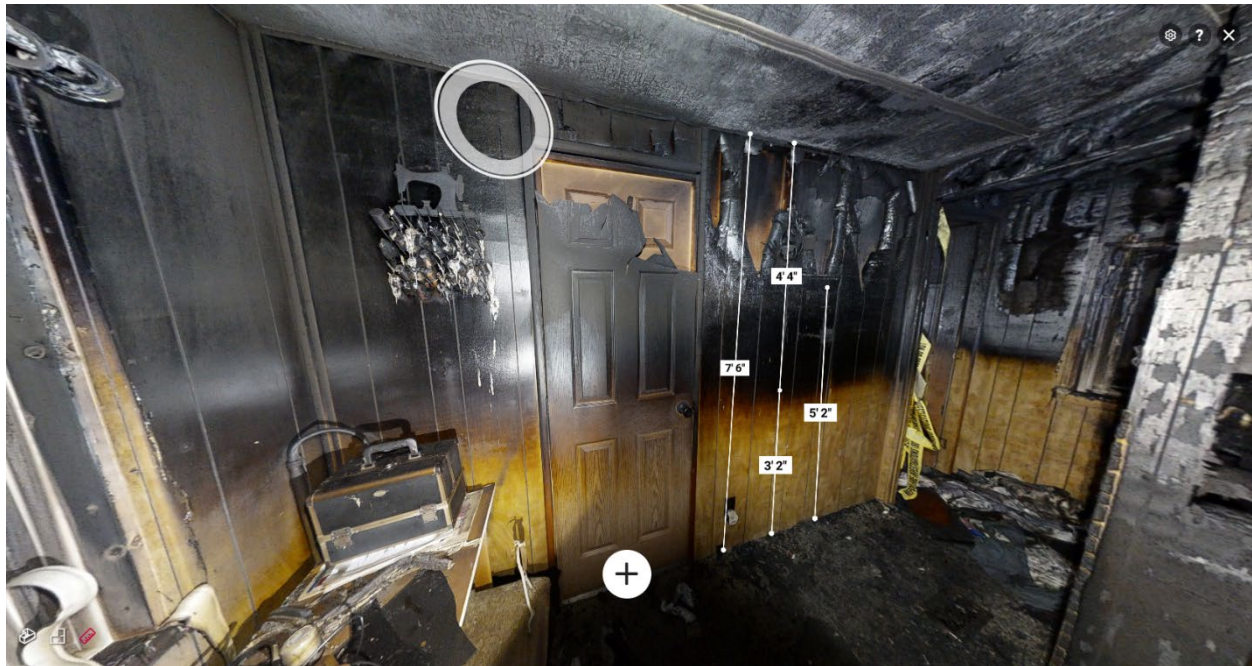
Mr. Karasinski's rebuttal report further demonstrates that the thermal layer never reached the height of the laptop even at the maximum intensity of this fire, which would have been reached long after the thermal runaway reaction had already occurred. Measurements taken from 3D camera photographs demonstrate the lowest point reached by the thermal layer in the room where the fire began and the laptop was located was three feet, two inches above the floor. The height of the desktop in the armoire on which the subject laptop was located was only two feet, two inches above the floor. (See Figures 1 & 2 below). Thus, the thermal layer speculated by Dr. Horn as the cause of thermal runaway in the laptop battery pack never reached the level of the laptop and could not have provided a sufficient heat source to independently provoke thermal runaway reactions in multiple battery cells.

*Figure 1 - Showing measured heights of lowest point reached by thermal layer (from Karasinski rebuttal report).*

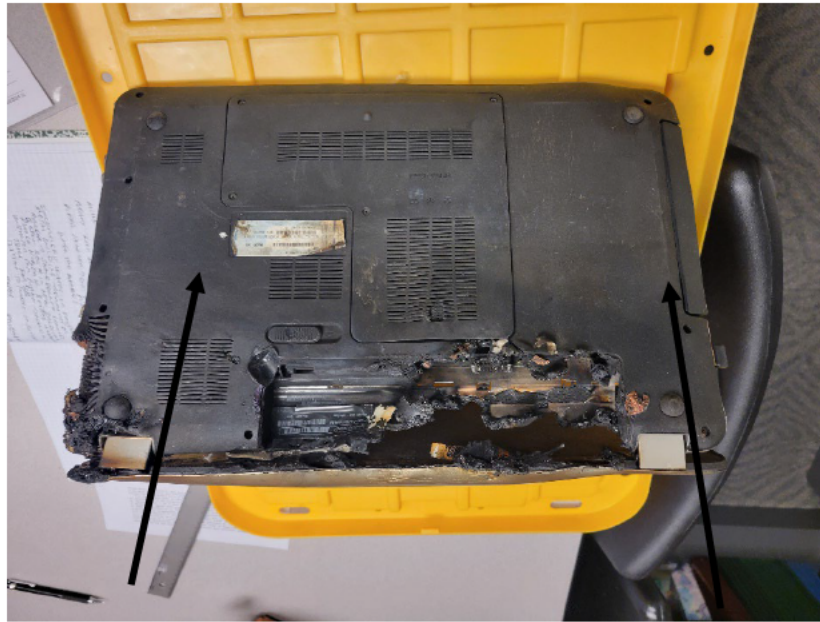
Indeed, the speculation that an external heat source caused the overheating of the battery cells is further refuted by examination of the bottom of the laptop in the area where the battery pack was located. Figure 4 is a photograph of the bottom of the laptop taken by the author that clearly shows a majority of the compartment where the battery pack was located completely melted and burned away. However, areas only slightly away from this region are essentially undamaged. The speculation of the Horn report is that a room-wide thermal layer descended upon the laptop from the ceiling and caused the laptop to get hot enough to cause the batteries thermally insulated inside the laptop and battery pack to reach thermal runaway. My Figure 4 clearly refutes this speculation. The thermally exposed left and right sides of the laptop are essentially undamaged. Had the speculated thermal layer descended upon the whole of the laptop it certainly would have heated the sides of the laptop to the extremely high temperature required to cause the cells inside the battery pack to reach thermal runaway. This is not seen in the evidence of the subject laptop. The sides of the laptop that would have experienced the full impact of the speculated thermal layer are undamaged.

Rather, consistent with the whole body of actual evidence and testimony is that only the area of the battery pack definitively demonstrates exposure to temperatures consistent with the thermal runaway inside the cells. Therefore, the thermal runaway reaction began in the cells and

the extreme temperatures within the cells caused total destruction of the bottom of the laptop in this region.

*Figure 4 – Photo of the bottom of the subject laptop (source S. W. Martin).*

As demonstrated in Figure 4 above, the progression in the extent of damage to the six cells, largely intact with little to no fire, complete fire burnout but with no explosion, and finally cell explosion and rupture, matches the pattern of the fire damage to the bottom of the laptop where the battery pack was inserted. Proceeding from left to right in Figure 4, the far left area of the battery pack is largely unburned and intact, whereas the far right side of the battery pack area is largely destroyed and burned away.

Not only is there no evidence of uniform damage to the entire laptop consistent with exposure to an external heat source that would be capable of causing thermal runaway in the battery pack, but the battery pack compartment on the bottom of the laptop where the battery pack was inserted does not show uniform thermal damage. As shown above, the left side of this battery pack compartment in Figure 4 was essentially unheated and remains mostly intact with even the labeling remaining undamaged. Conversely, the right side of this compartment shown in Figure 4 is almost entirely destroyed. Nor, for that matter, was there any thermal damage to the

Conversely, the evidence is entirely consistent with cell-level thermal runaway occurring internally from an overcharge, overvoltage and/or overtemperature condition in a cell on the right side of the battery pack as depicted in Figure 4, beginning a chain reaction that resulted in the explosion of two of the cells and destruction of the inner contents of two additional cells, leaving the remaining two cells largely intact.

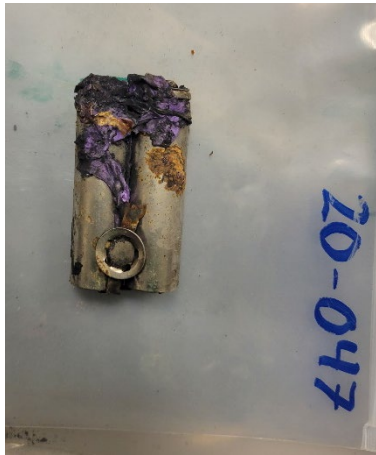
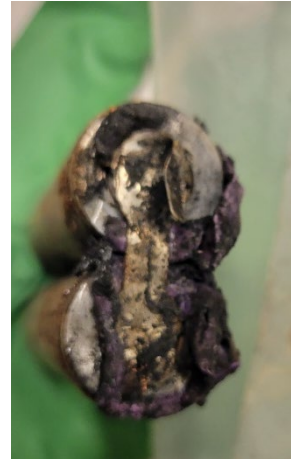
This chain of events not only explains what Ms. Marcellin witnessed, but is entirely consistent with the remnants of the 6 battery cells found in the room after the fire. Two of the cells were found to have violently ruptured from an internal explosion. Two of the cell casings were intact, but the contents of these cells had burned out completely. The remaining two cells

were found to be largely intact. Figures 5, 6, and 7 show pictures of these three sets of cells respectively.

*Figure 5 – Photographs of two of the six cells in the subject laptop that remained largely intact during the fire.*

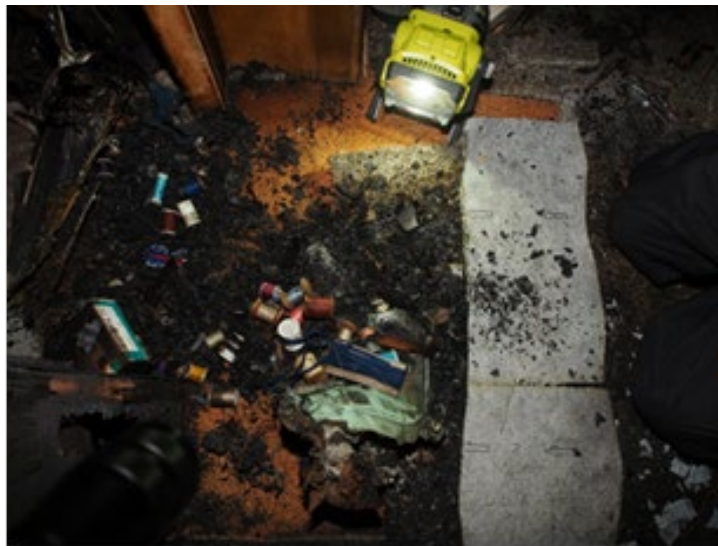
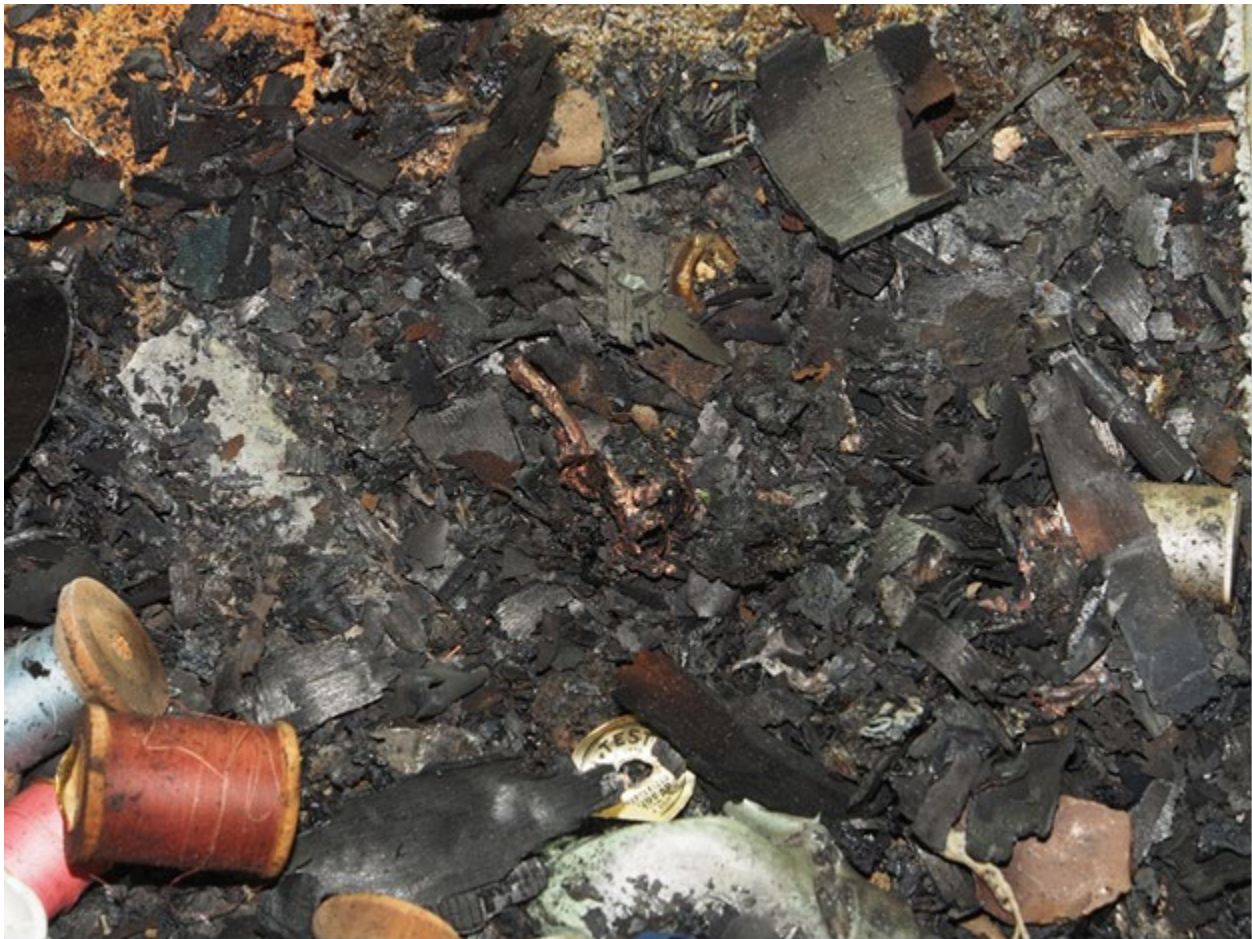
*Figure 8 Photograph of debris removed from closet for inspection (source Karasinski).*

*Figure 9 Closeup showing battery windings in debris removed from closet (source Karasinski).*

During thermal runaway reactions, it is common for flammable gases to explode and this can propel internal cell components and remnants of the cell case in all directions consistent with the remnants of one or more battery cells found inside the closet. (See Figures 8 & 9). The results of such explosions are evident in the ruptured cell casings depicted in Figure 5.

Ms. Marcellin's testimony of smelling smoke and then visually witnessing smoke in the office and projectiles being ejected from the laptop is entirely consistent with the source of the fire being a thermal runaway reaction that began inside a single cell in the battery pack and then spread heat to other adjacent cells in the pack that sequentially produced the same reaction. Based on the physical evidence, it is the conclusion of FRT experts Krasinski and Litzinger that the flammable gases and projectiles from the battery pack started the fire that consumed the home. During a thermal runaway reaction, the internal battery cell components such as those found inside the closet where the fire began, could have reached temperatures as high 600 ° C (1,100°F), which is more than sufficient to cause combustible materials within the room including the closet to ignite and produce smoke which set off the smoke alarm.

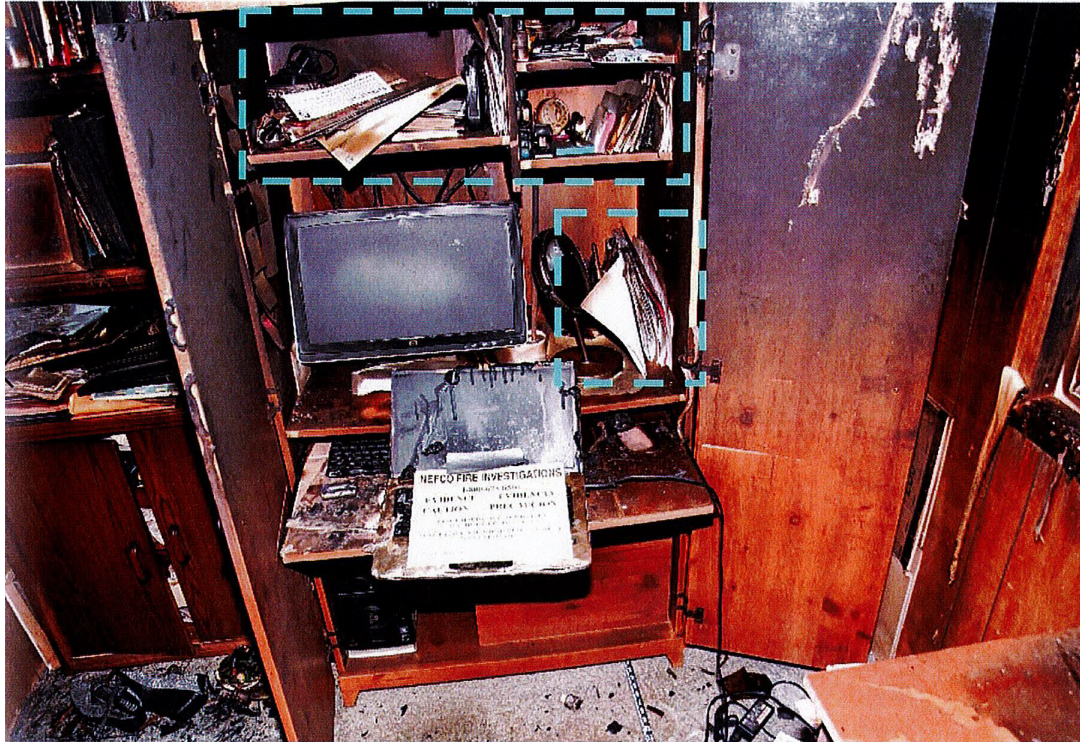
Counter to the external thermal layer hypothesis speculated by Dr. Horn, there were multiple combustible materials depicted in photographs of the armoire located at elevations above the level of the laptop that did not ignite.<sup>1</sup> (See Figures 10 and 11). Moreover, the older

external monitor which was located at a higher elevation on a shelf directly behind the laptop in the armoire does not show damage consistent with external temperatures in this range.<sup>2</sup> (See

*Figure 10 - Photo of armoire and laptop from Myers Report [Figure 19].*

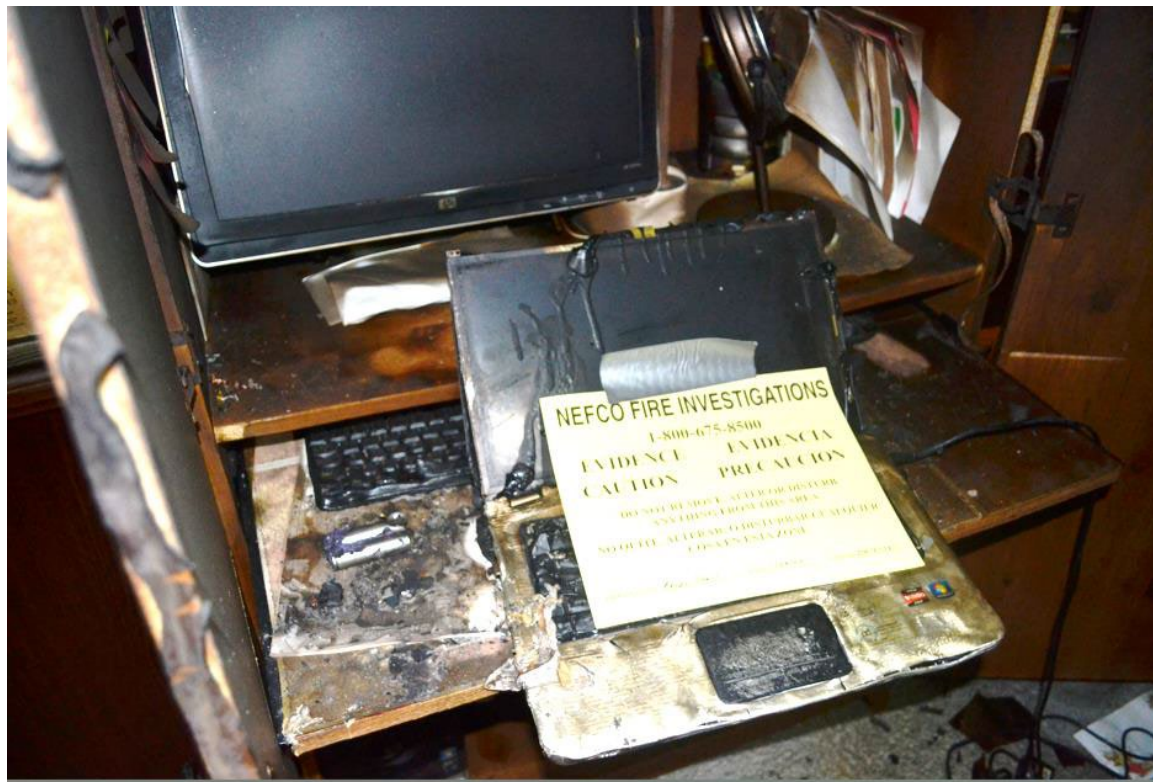
Figure 11, closeup of the external monitor where you can still read the control symbols on the bottom right of the monitor).

*Figure 11 - Closeup picture of the Armoire and Laptop from Karasinski Report [Figure 55].*
